Observed failures at railway turnouts: failure analysis, possible causes and links to current and future research

Abstract

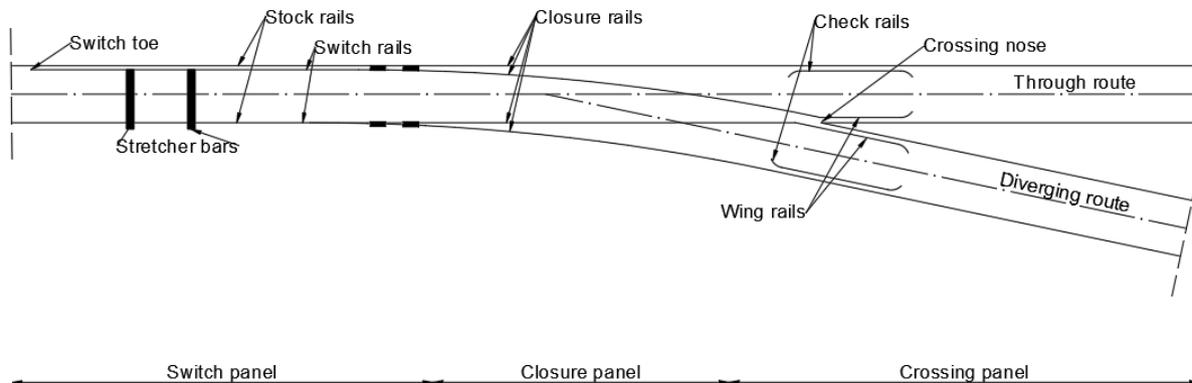
Figure 1 shows a typical layout for a right-hand turnout, which the vehicle can negotiate in four

Figure 1: Components of a single right-hand turnout.

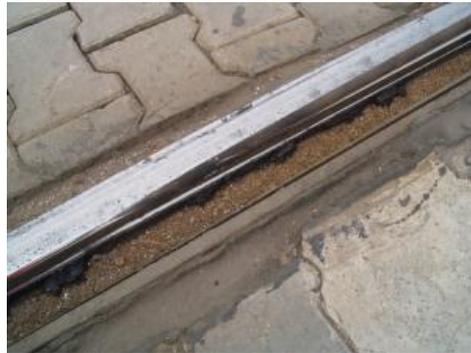
Wear of the switch/stock rail (Figure 2): The wear can occur simultaneously at the switch and stock rail or can be prevalent in one rail depending on the type of traffic and the main direction. This phenomenon is mainly caused by the high tensile forces the material is subject to and can be easily detected visually. Corrective measures include grinding of the metal flow and, in the worst cases, replacement of the whole assembly.

Figure 2: Wear at the stock rail [3].

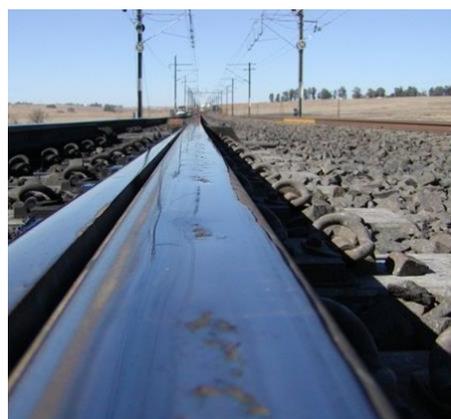
Spalling of the stock rail (Figure 3): The spalling mainly occurs in the wheel transfer area of the switch/stock rail due to the high contact stresses caused by non-optimal wheel/rail contact shape, such as in presence of worn wheels or incorrect profile of the wheel flange. This defect can be detected by visual inspection and can be corrected using deburring tools or grinding the surface. In the most severe cases, though, the replacement of the whole switch and stock rail assembly is required.

Figure 3: Spalling of the stock rail [3].

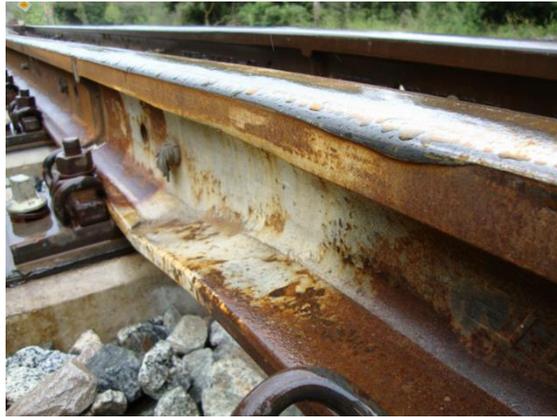
Soft spots (Figure 4): Soft spots are mainly present in the forged area of switch rails. They are characterised by a depression in the running surface due to local variation in metal hardness and strength loss caused by temperature changes during forging (i.e. heating and cooling stages). This defect can be detected by visual inspection and requires the replacement of switch rail.

Figure 4: Soft spots [3].

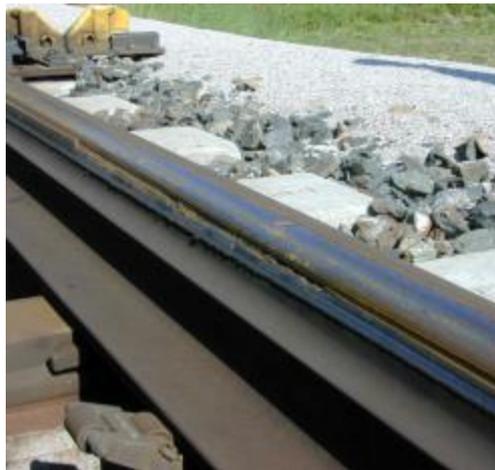
Lipping (Figure 5): Lipping mainly occurs in the wheel transfer area of the switch/stock rail appearing with a plastically deformed rail, especially at the switch blade, and possibly leading to material breakouts. This defect is caused by high stresses due to non-optimal wheel/rail contact, incorrect profile of wheel flange and poor maintenance. This defect can be detected by visual inspection and requires the replacement of switch and stock rail assembly.

Figure 5: Lipping of the switch blade [3].

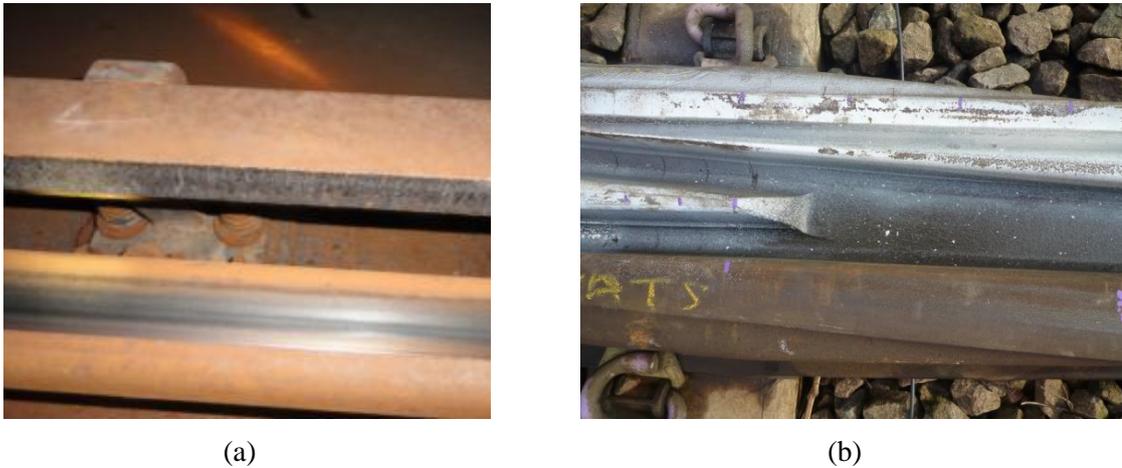
Wear on the crossing panel (Figure 6): Excessive wear can appear on the vertical surface of the check rails due to hard flange contact and on the running surfaces such as crossing nose/vee due to a variety of causes, such as excessively stiff bogies with low self-steering properties, excessively narrow check rail gaps, excessive high speeds in diverging direction and accelerating trains in the diverging route. If not corrected, this defect leads to further damage in the crossing area and safety issues due to the gauge corruption. This failure mechanism is generally detected through visual inspection and

Figure 6: Wear in (a) check rails [3] and (b) wing rail/crossing nose.

corrected through grinding or replacement of worn components when the wear limits are reached [25]. Preventative measures include the use of lubrication and appropriate rail materials (e.g. heat hardened steels).

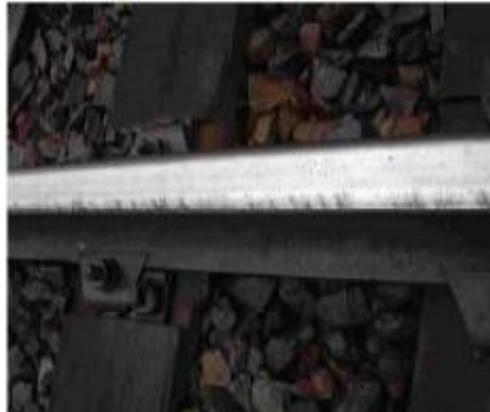
Head checks (Figure 7): Head checks are groups of fine surface cracks on the gauge corner of the rail caused by a gross plastic deformation due to wheel/rail contact friction (i.e. ratcheting mechanism). As the cracks are generally close together and are growing at a shallow angle into the rail, they merge underneath the rail surface to cause spalling of small areas. They can result in spalling of material pieces between cracks and in transverse cracks leading to probable rail fracture [26]. This failure mechanism is currently detected through visual inspection, eddy current and ultrasonic testing and requires grinding and/or replacement of the part.

Figure 7: Head checks [3].

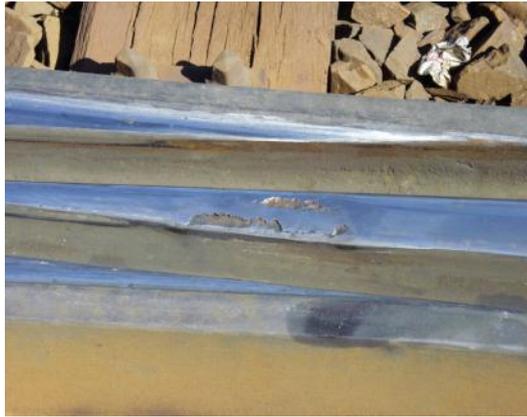
Spalling of the crossing (Figure 8): Spalling generally appears in the wheel transfer area and is a result of sub-surface initiation with subsequent merger of fatigue cracks. This defect is caused mainly by high dynamic forces due to non-optimal wheel transfer zone and poor support conditions, wheel flange not matching together with design of wheel transfer zone and inadequate control of wheel profile. It is currently detected through visual inspection.

Figure 8: Spalling of the crossing [3].

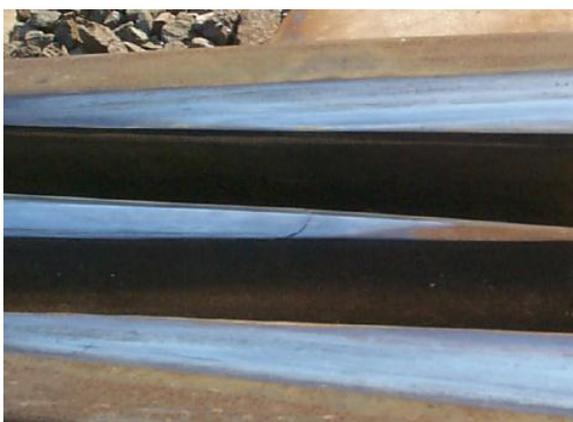
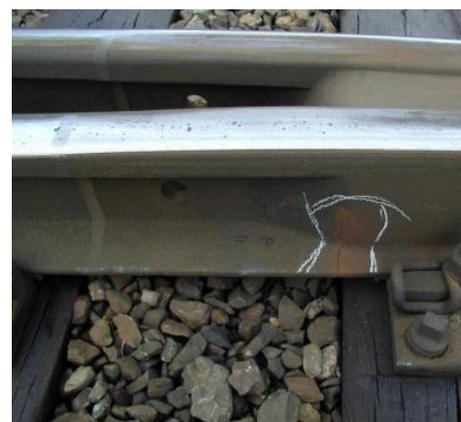
Cracks on the crossing (Figure 9): The cracks from the base of the crossing are a result of bending fatigue combined with stress-raising effects of machined geometry or surface / subsurface flaws. In the case of Austenitic Manganese Steel (AMS) crossings, leg ends are welded using an intermediate stainless insert and this can lead to hard microstructures that are more susceptible to cracking. Fatigue cracks can appear in the front area of the crossing nose as well as in the rear zone in the crossing. Possible causes can be high dynamic forces, poor support condition, inadequate control of wheel profiles and manufacturing defects, mainly casting porosity.

Transverse cracking in the rail or crossing foot (Figure 9(b)) generally initiates from a corrosion pit or a stress raising geometrical feature and can grow under cyclic loading resulting in a transverse break in the rail. Small corrosion pits are not detectable by current non-destructive test (NDT) techniques. Therefore, this failure mechanism is generally detected through visual inspection and, depending on location of the defect, corrected using weld repair techniques. However, the need for welding expertise and the careful control of temperature required for weld repair of AMS crossings is restrictive and leads to costly replacement. Semi-automatic repair using Flux Cored Arc Welding (FCAW) techniques are now being introduced to undertake such repairs. Further development of crossing repair using milling of the damaged area followed by FCAW is included in the follow-up research project to In2Rail.

Figure 9: Transversal cracks (a) on the crossing nose and (b) on the crossing foot [3].

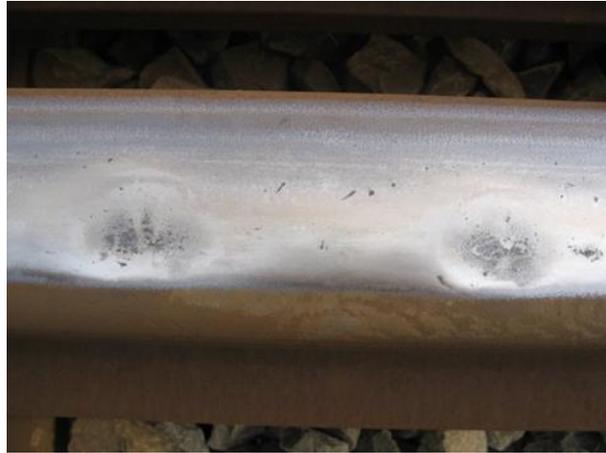
Squats (Figure 10): The squats are caused by RCF defect and appears on the running surface as a localised depression and a dark spot containing cracks with a circular arc or V-shape. The cracks propagate inside the head leading at the end to a rail break or spalling of the running surface in case of

high-speed turnout. They are often found on flash butt and aluminothermic welds. The main causes of squat formation are not generally well understood, but may include high contact stresses and localised microstructure change due to wheel micro slip. Current methods of detection include visual inspection, ultrasonic testing or magnetic crack detection. Grinding, repair by resurfacing when possible or complete replacement of the rail are among the most typical corrective measures.

Figure 10: Soft spot in plain line [3].

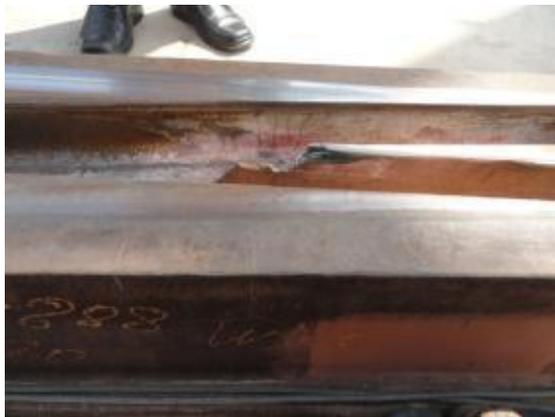
Plastic deformation of the crossing nose (Figure 11): Plastic deformations are characterised by yielding of the crossing due to the high lateral contact forces through non-optimal wheel/rail contact surfaces or incorrect geometry. This failure mechanism is generally detected through visual inspection and track geometry checks and corrected through repairs to the crossing nose (i.e. welding, grinding) or full replacement. In the worst cases, a replacement may be needed.

Figure 11: Plastic deformation of the crossing nose [3].

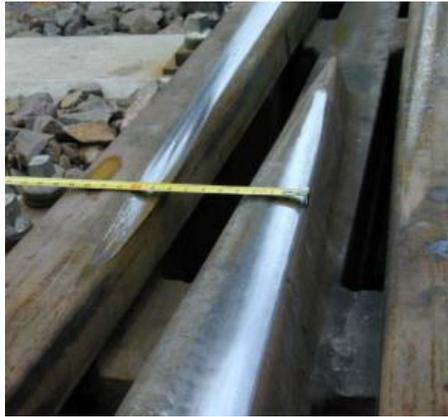
Plastic deformation of the wing rail (Figure 12): This type of plastic deformation is characterised by a depression in the running surface and metal flow leading to the formation of burr on the inner side of the wing rail, material breakouts and spalling of the running surface. Generally, it is caused by the presence of high dynamic forces due to sub-optimal wheel transfer through the crossing or inadequate control of wheel profile shape. It is generally detected through visual inspection and track geometry checks and it is corrected resurfacing with weld build-up techniques or full replacement with alternative hardened materials.

Figure 12: Plastic deformation of the wing rail [3].

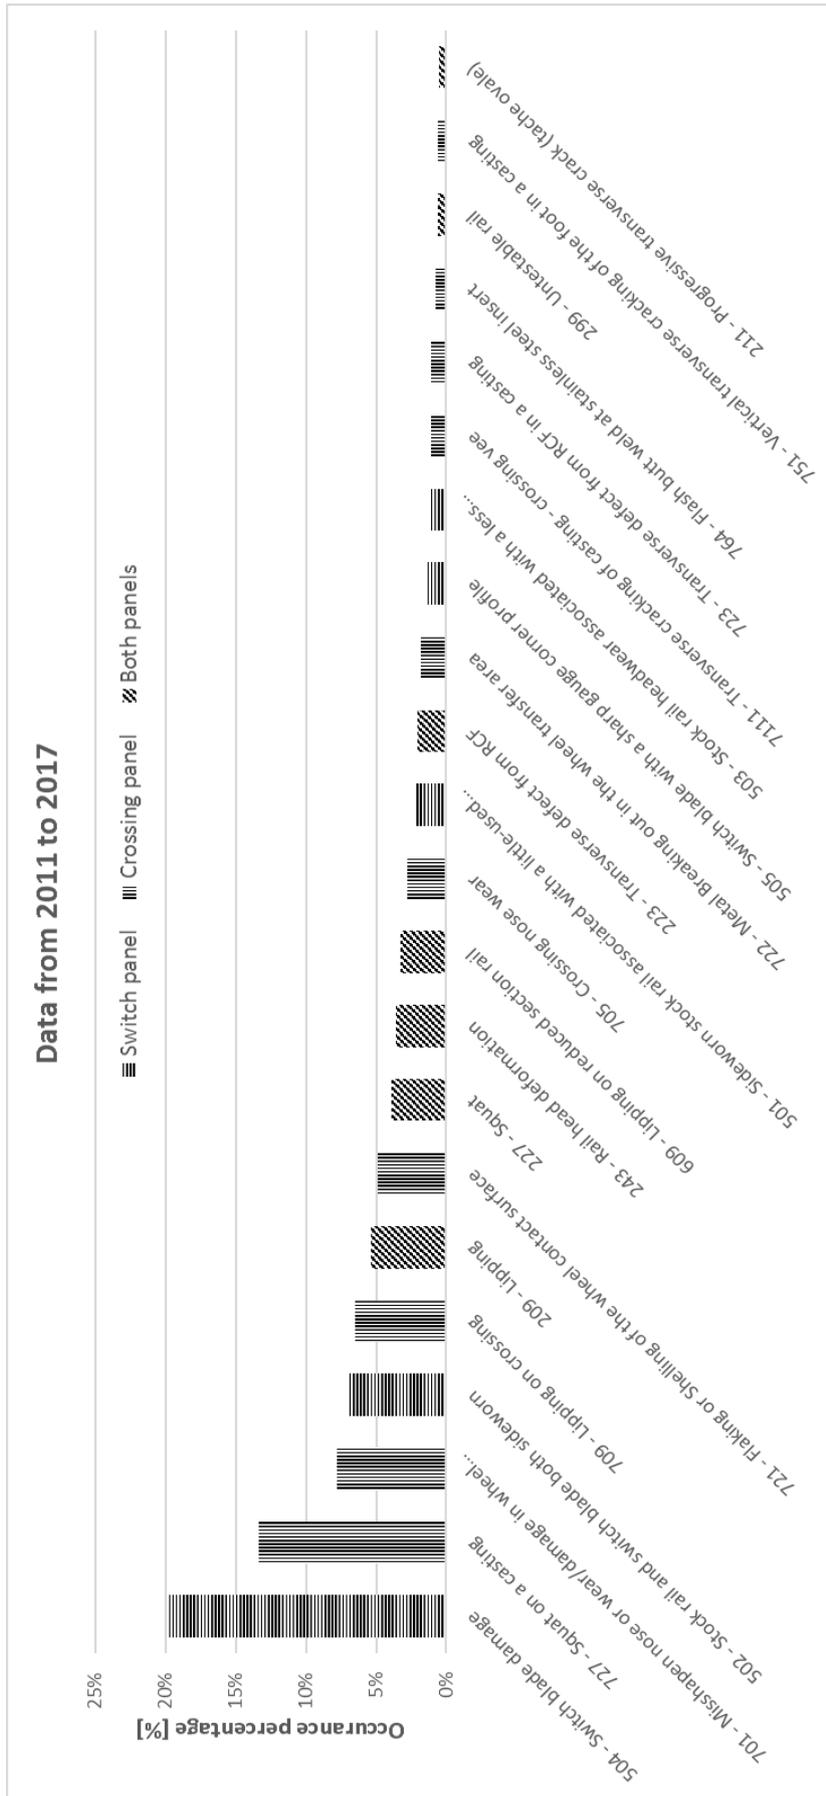
The percentage occurrence of the 22 most common failure types at S&C on the GB network between 2011 and 2017 as identified in the database is presented in Figure 13.

Figure 13: The 22 most common reported failures at S&Cs in the GB network from 2011 to 2017.

The data in Figure 13 indicates that most of the identified defects occur on the switch blade (code 504) accounting for approximately 1/5 of all reported failures during the seven years considered. This matches common understanding that the switch blade, characterised by a reduced section, is the weakest component of the system. As a train traverses the switch, high dynamic forces, and thus contact stresses, are almost instantaneously applied to this structurally already weak part of the track contributing to develop damage. Although the need for stronger materials appears an obvious choice, deployment of premium heat treated grades has not been successful. More recently, Network Rail (NR) introduced their premium grade HP335 in turnout installations but the experience was again considered unsuccessful and the its use has been discontinued. Consequently, it is apparent the loss of structural integrity of the reduced cross section could not be compensated through the use of higher strength steels. However, a low carbon carbide-free bainitic steel has been approved and used successfully by SNCF for fixed crossings. The use of this grade for switch manufacture should also be considered.

Despite the single highest number of failure type being associated with the switch panel and the switch blade, the crossing panel accounts for the highest cumulative number of overall failures, with more than half of the total failures.

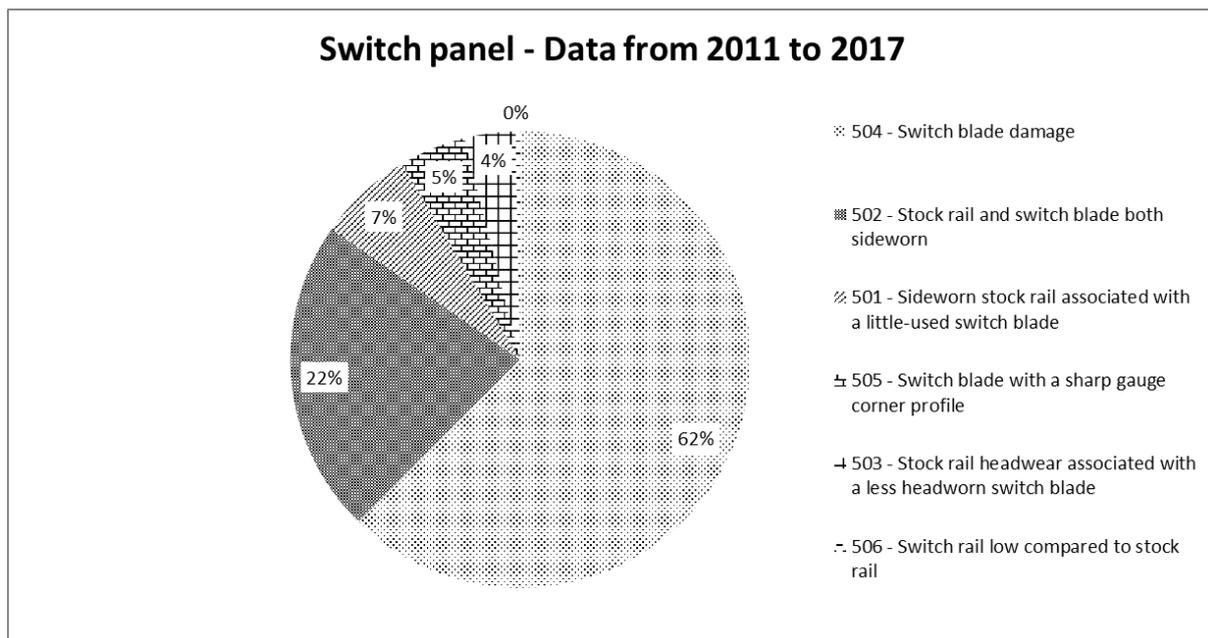
Figure 14: Reported failures at the switch panel in the GB network from 2011 to 2017.

As anticipated in Figure 13, Figure 14 confirms that the switch blade damage is the most common damage occurring at the switch panel, representing approximately 2/3 of the total failure occurrences. The results from the text analysis show that almost half of the entries (i.e. 47%) refers to “lipping” as the damage mode. Cracks or breaks have a lower occurrence rate, which is 7% and 5% respectively, however they might more severely affect running services and accrue to higher delay costs. The RCF mechanism, instead, has a very low occurrence rate (0.5%).

The second most common damage mechanism is the coexisting wear of stock and switch rail (22% of the total reports). It is about 3 times more frequent than the case of wear only occurring at the stock rail. Although materials with higher resistance to wear (higher hardness steels) are available, this needs to be balanced against the risk of RCF crack growth and reduced ductility. This aspect is further

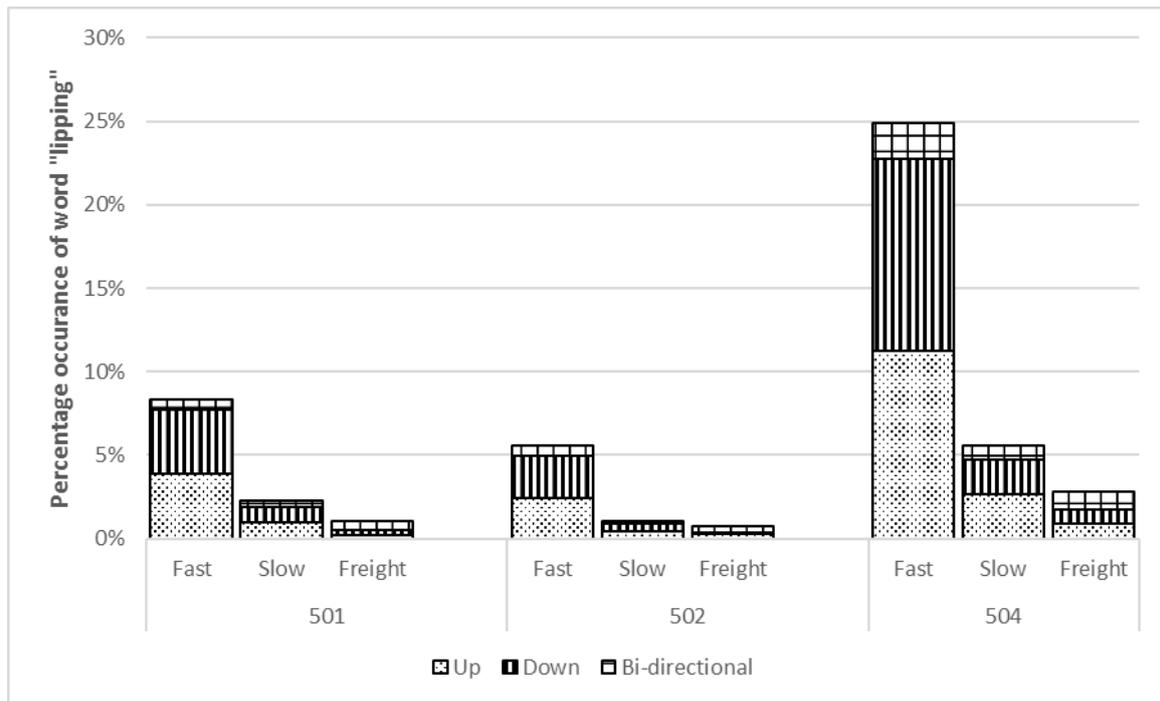
In order to understand a possible relationship between the lipping phenomenon and the wear mechanisms, the free-text analysis has been applied to the three most common failures at switch panel (i.e. codes 501, 502 and 504) searching for the word “lipping” (Figure 15). Three types of traffic directions, which are up, down and bi-directional, and three types of track types, which are fast, slow and freight, have been considered².

Figure 15: Percentage occurrence of the word “lipping” in the three most common damage mechanism at switch panel.

Code 501 refers to cases in which the most used direction is the through route with substantial cant deficiency, i.e. in a curved track [28]. This failure mode in association with lipping is mainly linked with the up and down directional traffic on the fast lines. Similar conclusions can be drawn for the code 502 and 504. Overall, code 504 shows highest percentage occurrence of the word lipping in the free text report, highlighting the fact that lipping is highly associated with general switch blade damage reporting especially on fast lines (25%).

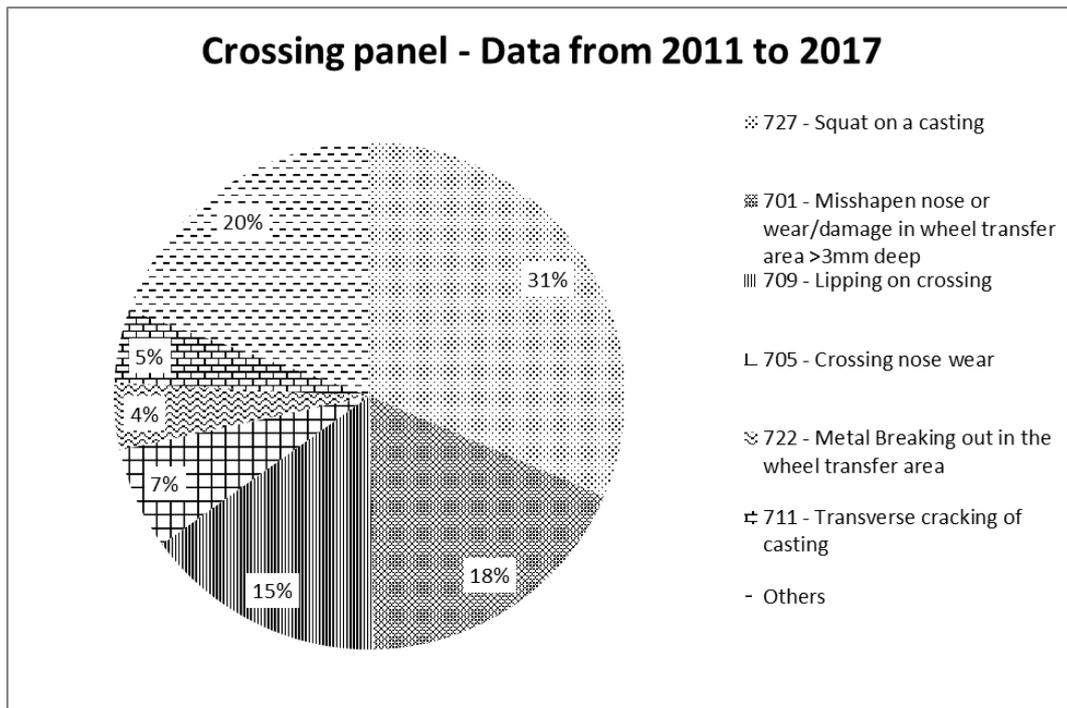
Figure 16: Reported failures at the crossing panel in the GB network from 2011 to 2017.

Although the database results suggest 19 types of failures within the crossing panel, 80% of the failures are accounted for by just 6 failure types (Figure 16). In contrast, 5 failure types account for virtually all failures within the switch panel.

The most common cause of failure at the crossing panel is reported as squat on a casting, representing approximately 1/3 of all the turnout failures, and the second largest defect category (Figure 13). The data analysis combined with the text analysis has shown that the most common location of defects is the nose (46% of the total occurrence), followed by the leg end (10%) and the wing rail (10%). In 34% of cases it is not possible to conclude the location from the text analysis, since the location was either not specific, or was written in a way that was not detected by the analysis. High wheel-crossing contact stresses are the primary source of degradation, particularly at the crossing nose and wing rail. These stresses can be amplified by a wide range of factors, including non-optimal profiles, incorrect installation and insufficient maintenance [3]. These types of faults can be exacerbated by the presence of sub-surface flaws that are more prevalent in castings compared to rolled rails used in fabricated crossings. This finding is confirmed by the data analysis which shows that 41% of the squat failures occur in cast crossing, 4% in fabricated crossing, while 55% is unspecified. Unfortunately, the text analysis has not resulted in any additional useful information.

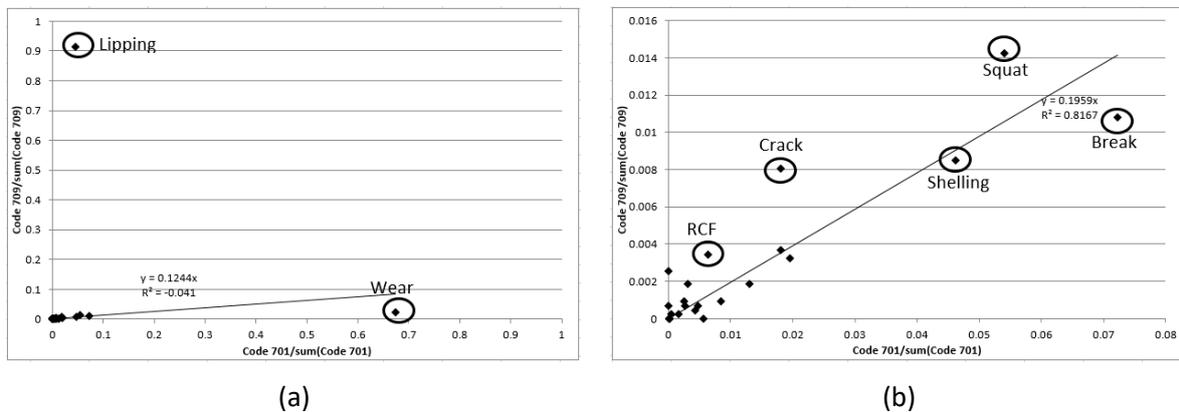
A text analysis has been carried out on two failure codes, i.e. code 701 (“misshapen nose”) and code 709 (“lipping”). Figure 17 shows the correlation of the relative occurrence of specific words in relation to each types of reported defect. From Figure 17(a) it is possible to see that there are relatively few of the word searched for relating to either defects as most of the data points are centred around the origin, with the exception of one or two points. These are:

- ‘wear’ which is commonly associated with the misshapen nose (code 701), but not with lipping (code 709); and

- lipping is as expected highly correlated with lipping (code 709) and not commonly associated with misshapen nose (code 701).

Removing these points, it is possible to focus on the term with relatively low occurrences (i.e. less than 8% for code 701 and less than 2% for code 709). Around the origin (Figure 17(b)), there is similar occurrence rate of each highlighted terms with each defect codes. In particular, ‘shelling’ is equally relevant for misshapen nose and lipping. The term ‘break’ is slightly more relevant for misshapen nose as this can eventually lead to breakage of material on the nose, while ‘squats’, ‘crack’ and ‘RCF’ are slightly more relevant for lipping as lipping can eventually leads to or resemble cracks generate by squats and RCF. In all cases, a misshapen nose is likely caused by combined high vertical impact forces with large lateral offset of the axle towards the crossing, in combination with early load transfer in on the nose where its width is too small to structurally withstand the load. Finally, lipping is associated with high lateral creep forces.

Figure 17: Relationship between misshapen nose and lipping percentage occurrence (a) including the outliers and (b) excluding the outliers.

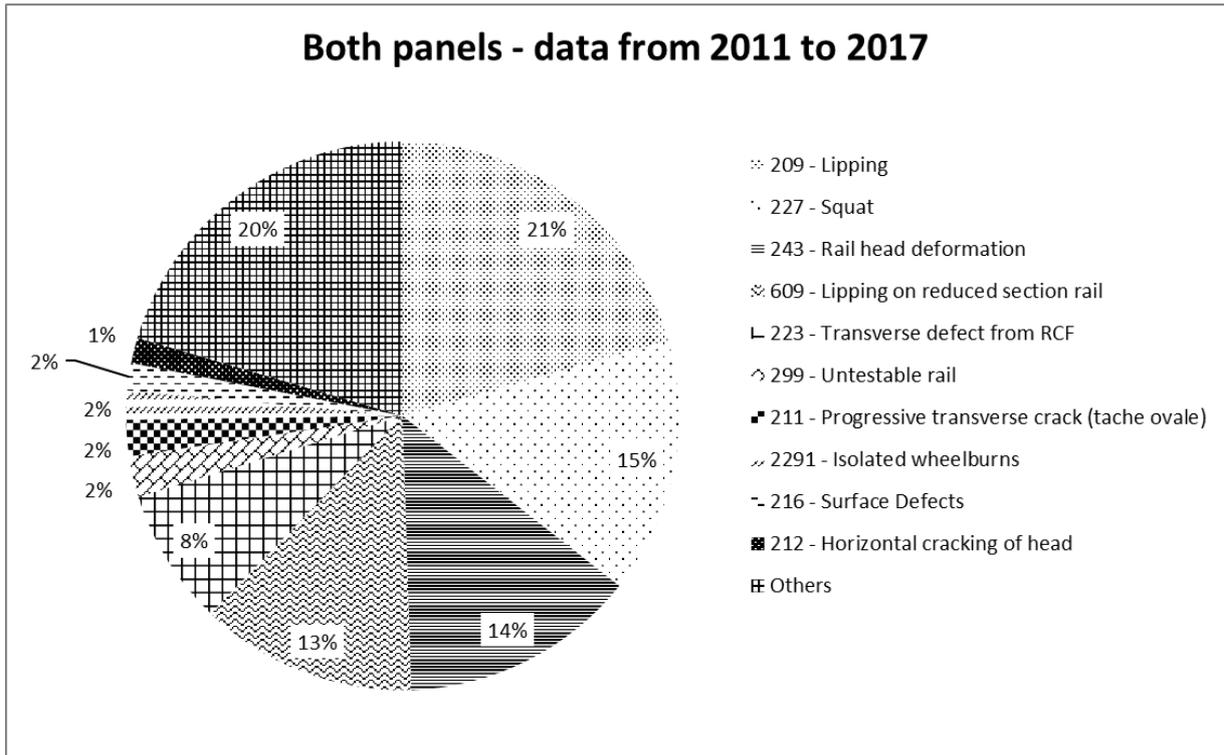
Figure 18: Reported failures occurring at both panels in the GB network from 2011 to 2017.

From Figure 18 it is possible to deduce that the most common cause of failure at the both panels is lipping, representing approximately 1/5 of all the failures. Defect 209 (lipping), defect 243 (rail head deformation) and defect 609 (lipping on reduced rail section) represent approximately 48% of the total failures occurring in both panels. This fact clearly shows a need for high yield strength materials.

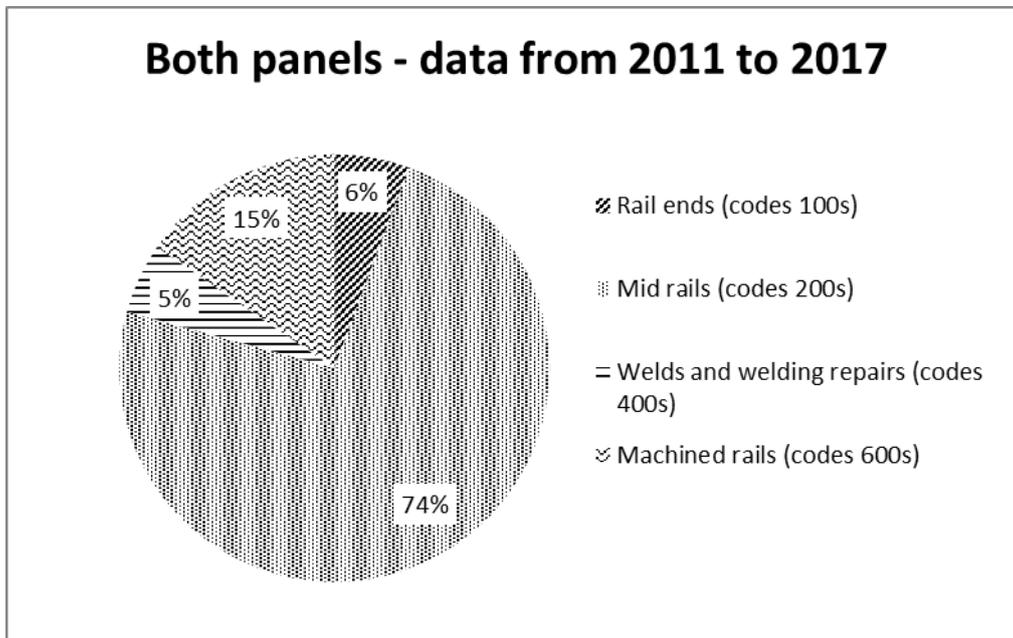
Figure 19 shows the occurrence percentage of the observed failures divided accordingly to code groups and Figure 20 the most commonly observed failures per each code group.

Figure 19: Groups of reported failures occurring at both panels in the GB network from 2011 to 2017.

- Mid rails (74% of the total failures at both panels as in Figure 19):

- Machined rails (15% of the total failures at both panels as in Figure 19):

- Rail ends (6% of the total failures at both panels as in Figure 19):

- Welds and welding repairs (5% of the total failures at both panels as in Figure 19):

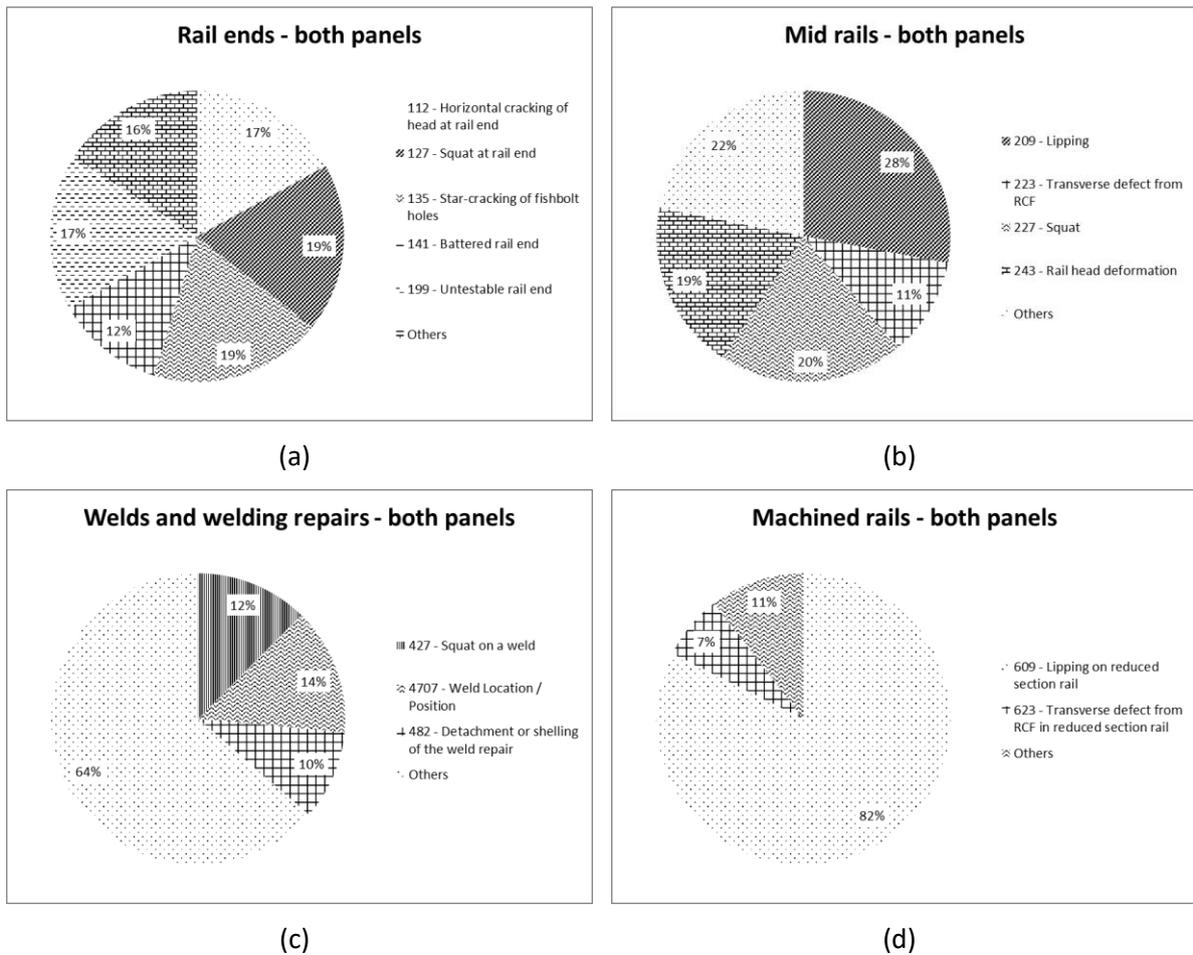
Figure 20: Most common reported failures depending on the main group types occurring at both panels ((a): rail ends; (b): mid rails; (c): welds and welding repairs; (d): machined rails).

Four main groups of observed failures are considered (see the failure codes in RDMS data, Figure 19 and Figure 20):

“Reduced section rail” refers to the machined parts of the S&C panels, such as switch rail, wing rail, check rail, etc... As expected, plastic deformations and RCF mechanisms reaches up to 90% of the total failure modes in the reduced section rails.

The RCF mechanisms at the rail end are the dominant failure causes of fish blade joints, reaching 41%, followed by failures of the fishbolt holes (up to 25%) and battered rail ends (up to 12%).

There are a large variety of failure mechanisms occurring at weld location, which are mainly linked with the process used (such as aluminothermic/flash-butt/arc welding process [29]) and the relative position of the two parent rails (specific standards, as in [30, 31], have been issued to avoid this problem). Unfortunately, it is not possible to separate between failures at or near tri-metal welds joining rails with legs of cast crossings as such welds remain a welding challenge.
